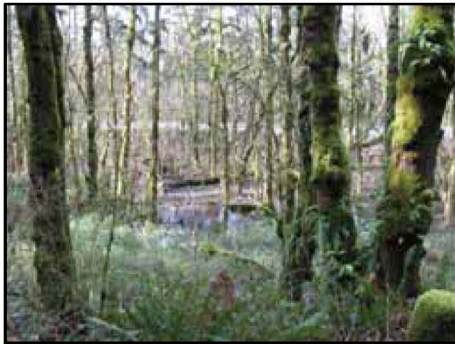
Wetlands border the western property line. These wetlands are home to a wetland mixed broadleaf forest, and trees including Oregon ash, black cottonwood, red alder, and western red cedar. Shrubs include vine maple, salmonberry, and Nookta rose. The current access road to the site passes through this area.

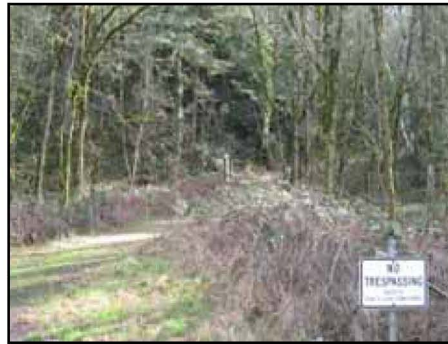
Current site access point. The site is posted "No Trespassing." The road is an old logging access road and would need to be improved for public access (paving, widening, sidewalks, etc.)

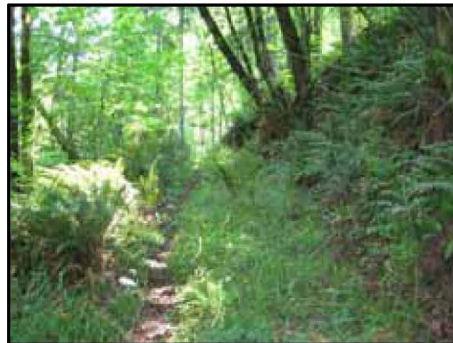
A user-created trail leads to the top of the wall. This trail is steep and rocky, and would not be sustainable under intensive use. The existing terrain will make it difficult to develop a low-impact, family-friendly trail that connects the upper and lower sections.
